HO-49

Mount Hebron (Mt. Hebron)

Architectural Survey File

Mt. Hebron

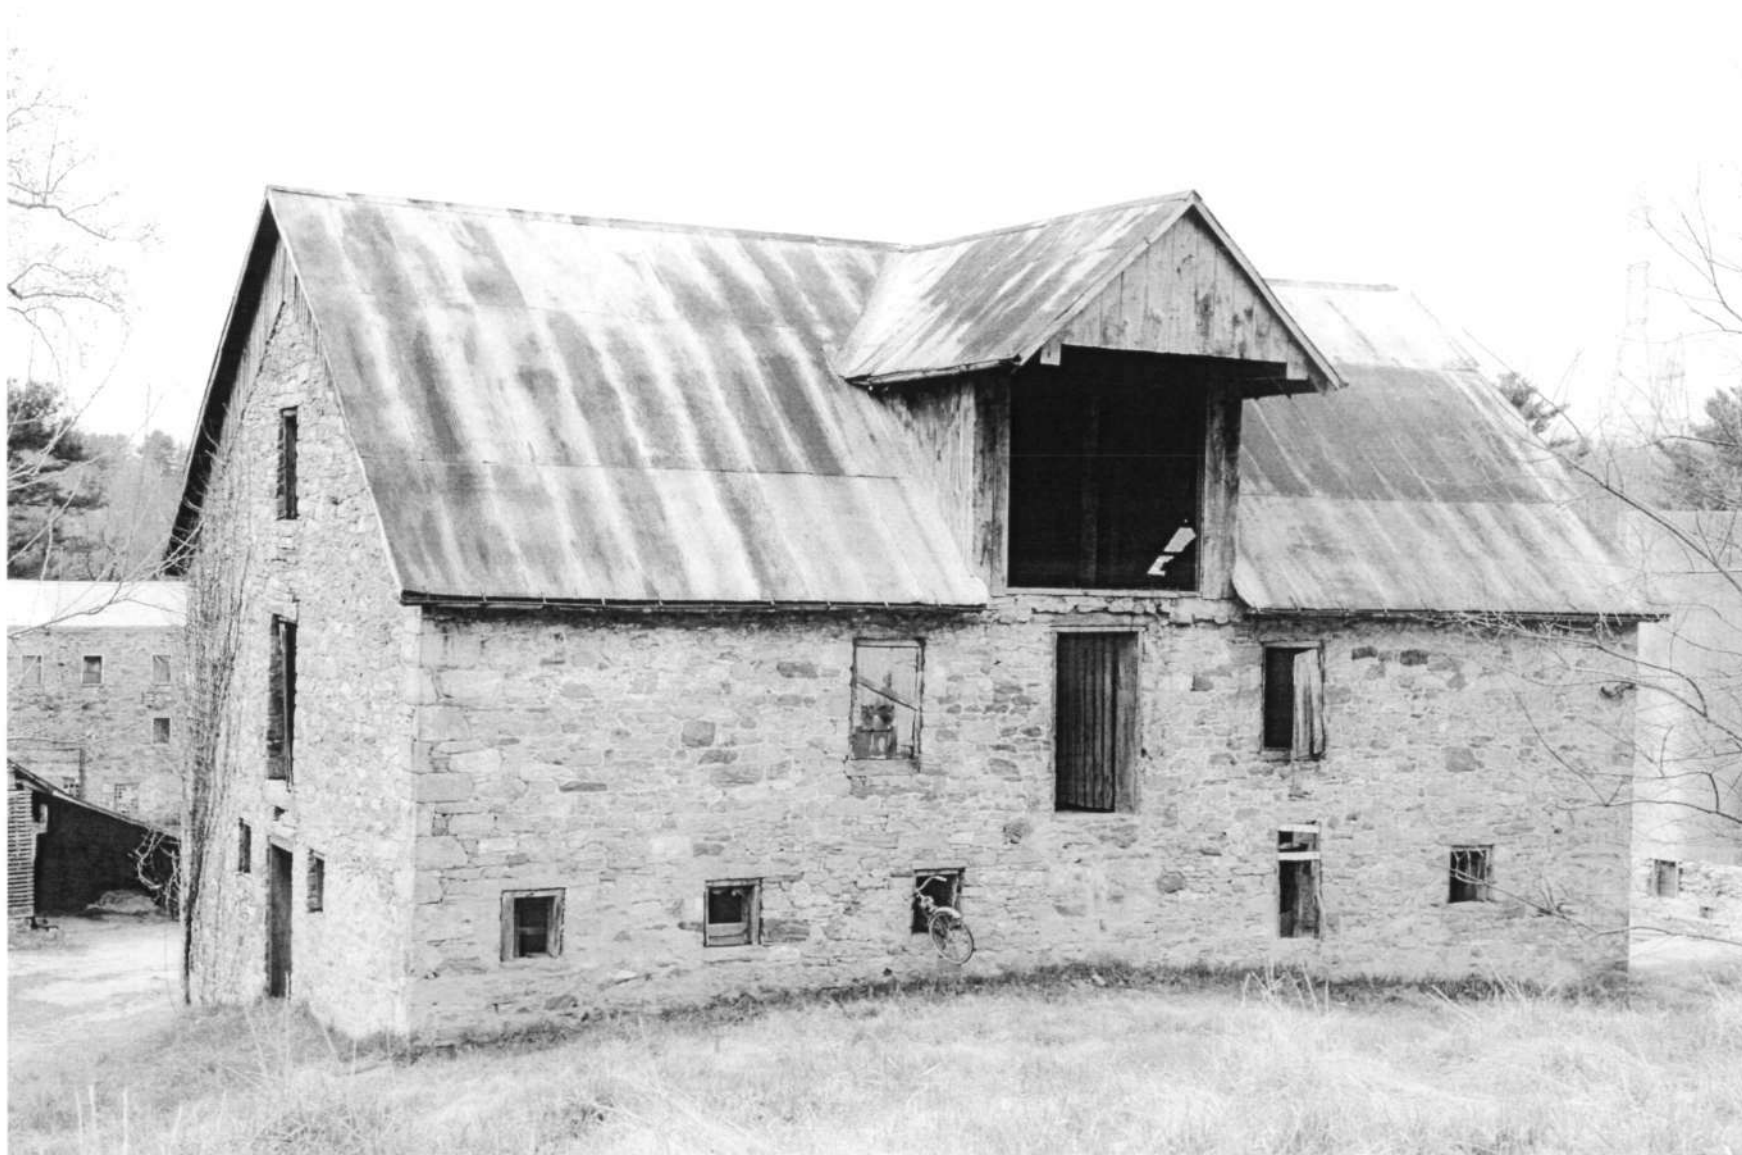
HO- 49 Mount Hebron, Calvin Circle & Furrow Avenue Stone Barn/Slave Quarter, northeast elevation
Ken Short, April 2006, 18/30

The slave quarter (ca. 2nd quarter 19th c.), a multi-purpose 2 1/2-story stone building in fair to good condition, is set on the west side of the farm lane between the bank barn and the manor house. The gable-roofed stone building has a corrugated metal roof. Wood louvers infill window openings and door openings hold wood doors. Window and door openings have stone sills and lintels. While structurally sound, the building has been empty for decades and is suffering from deferred maintenance.

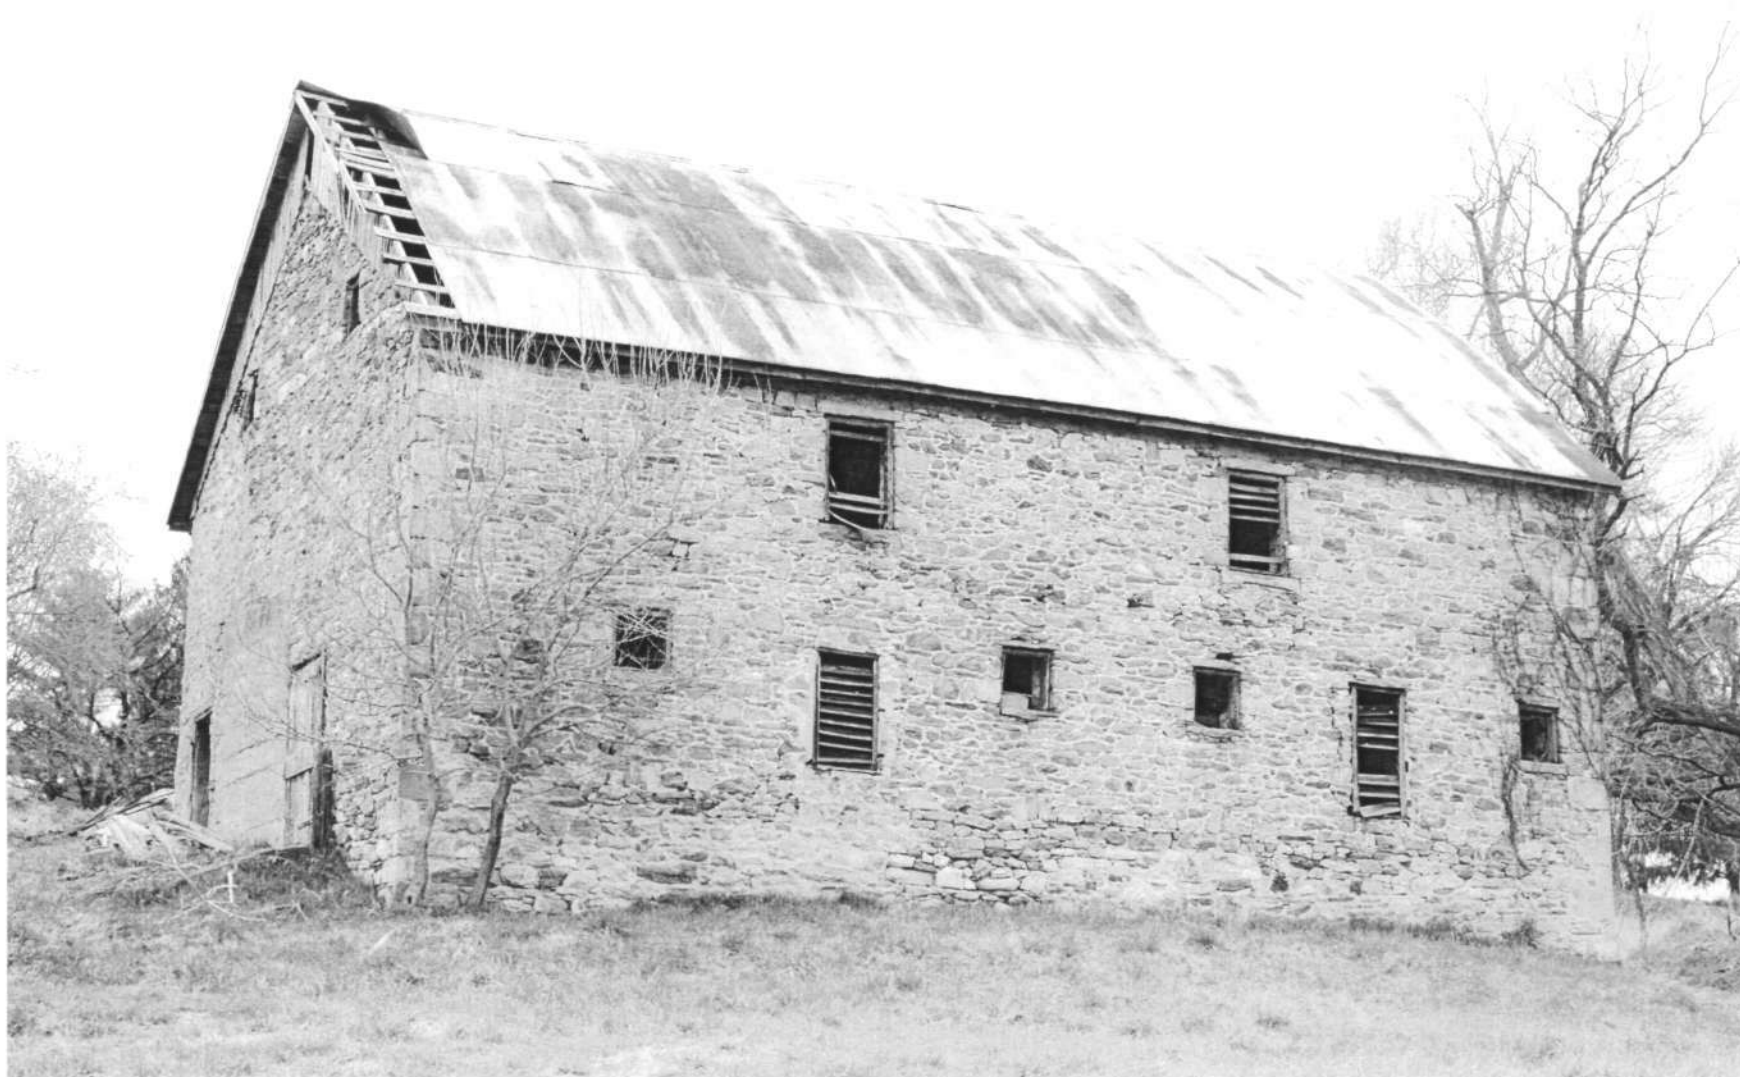
HO- 49 Mount Hebron, Calvin Circle & Furrow Avenue Stone Barn/Slave Quarter, southwest elevation
Ken Short, April 2006, 19/30

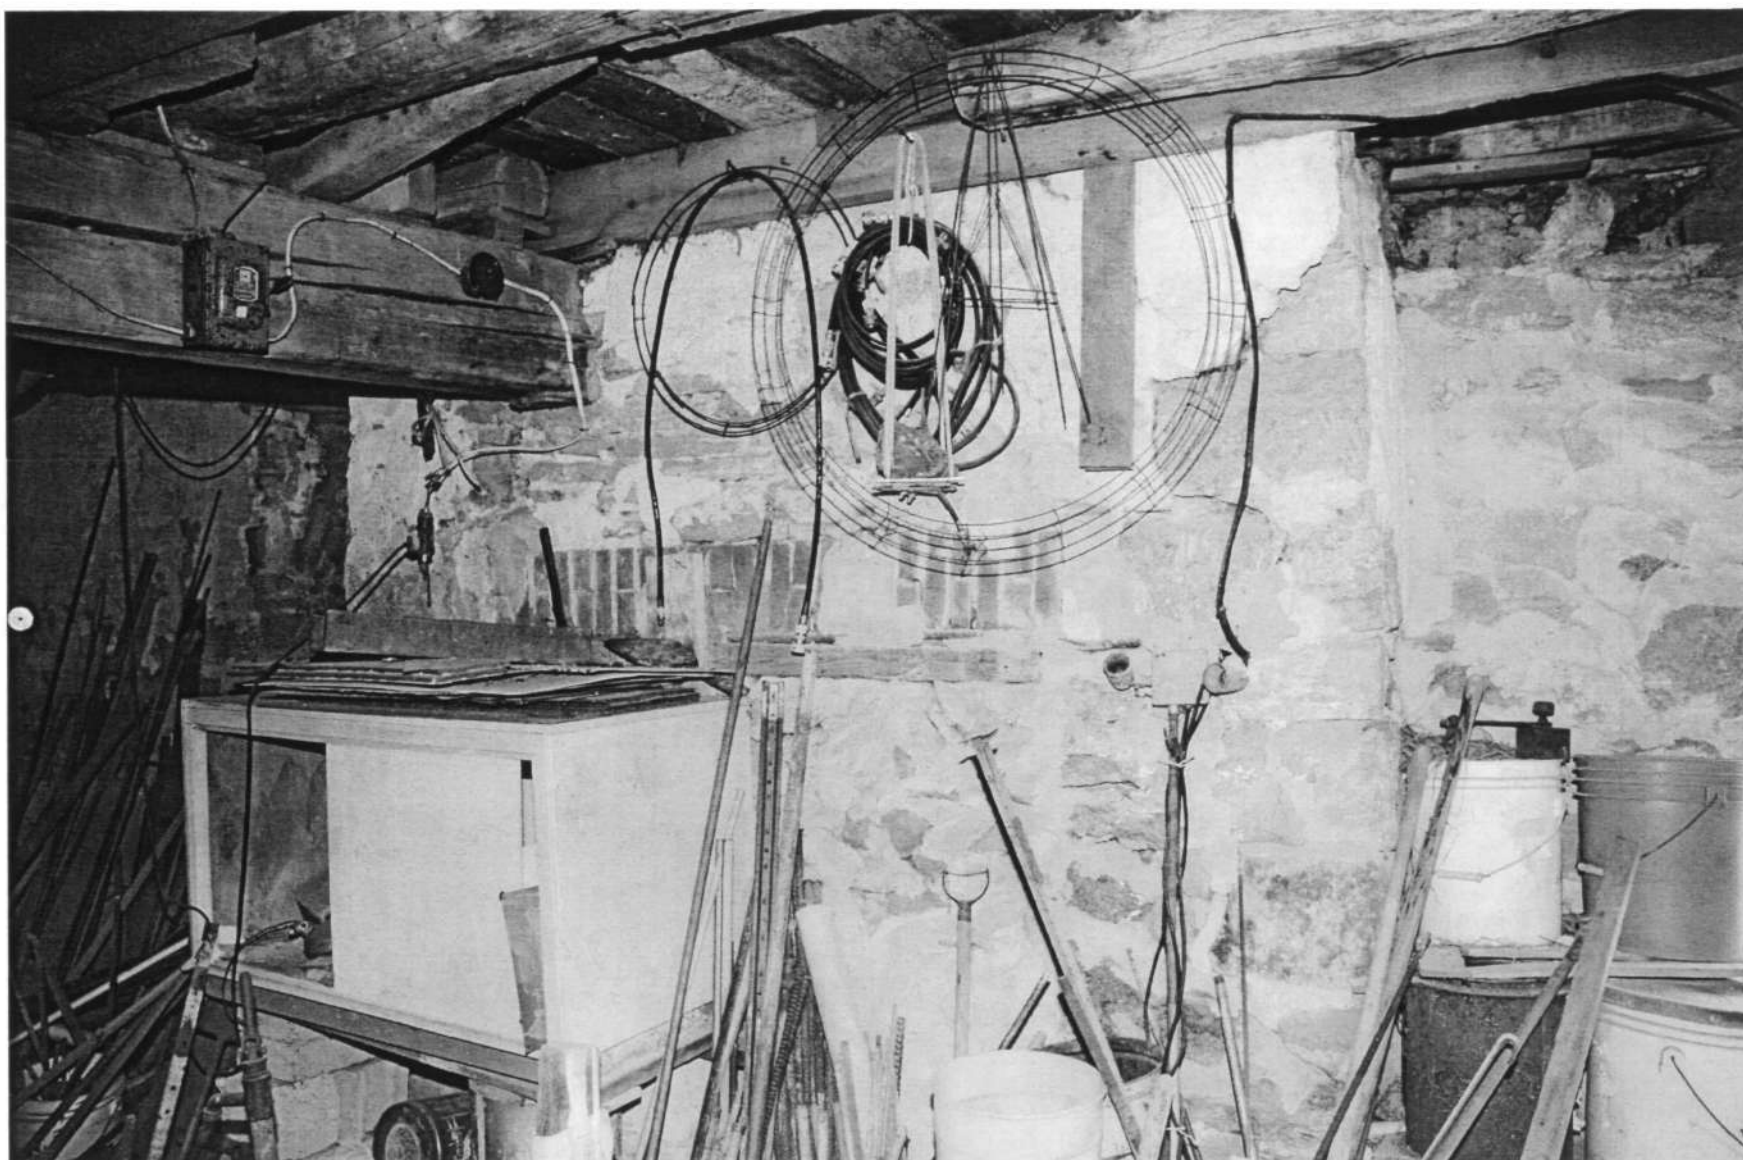
HO- 49 Mount Hebron, Calvin Circle & Furrow Avenue Stone Barn/Slave Quarter, first story, fireplace on northwest
Ken Short, April 2006, 21/30

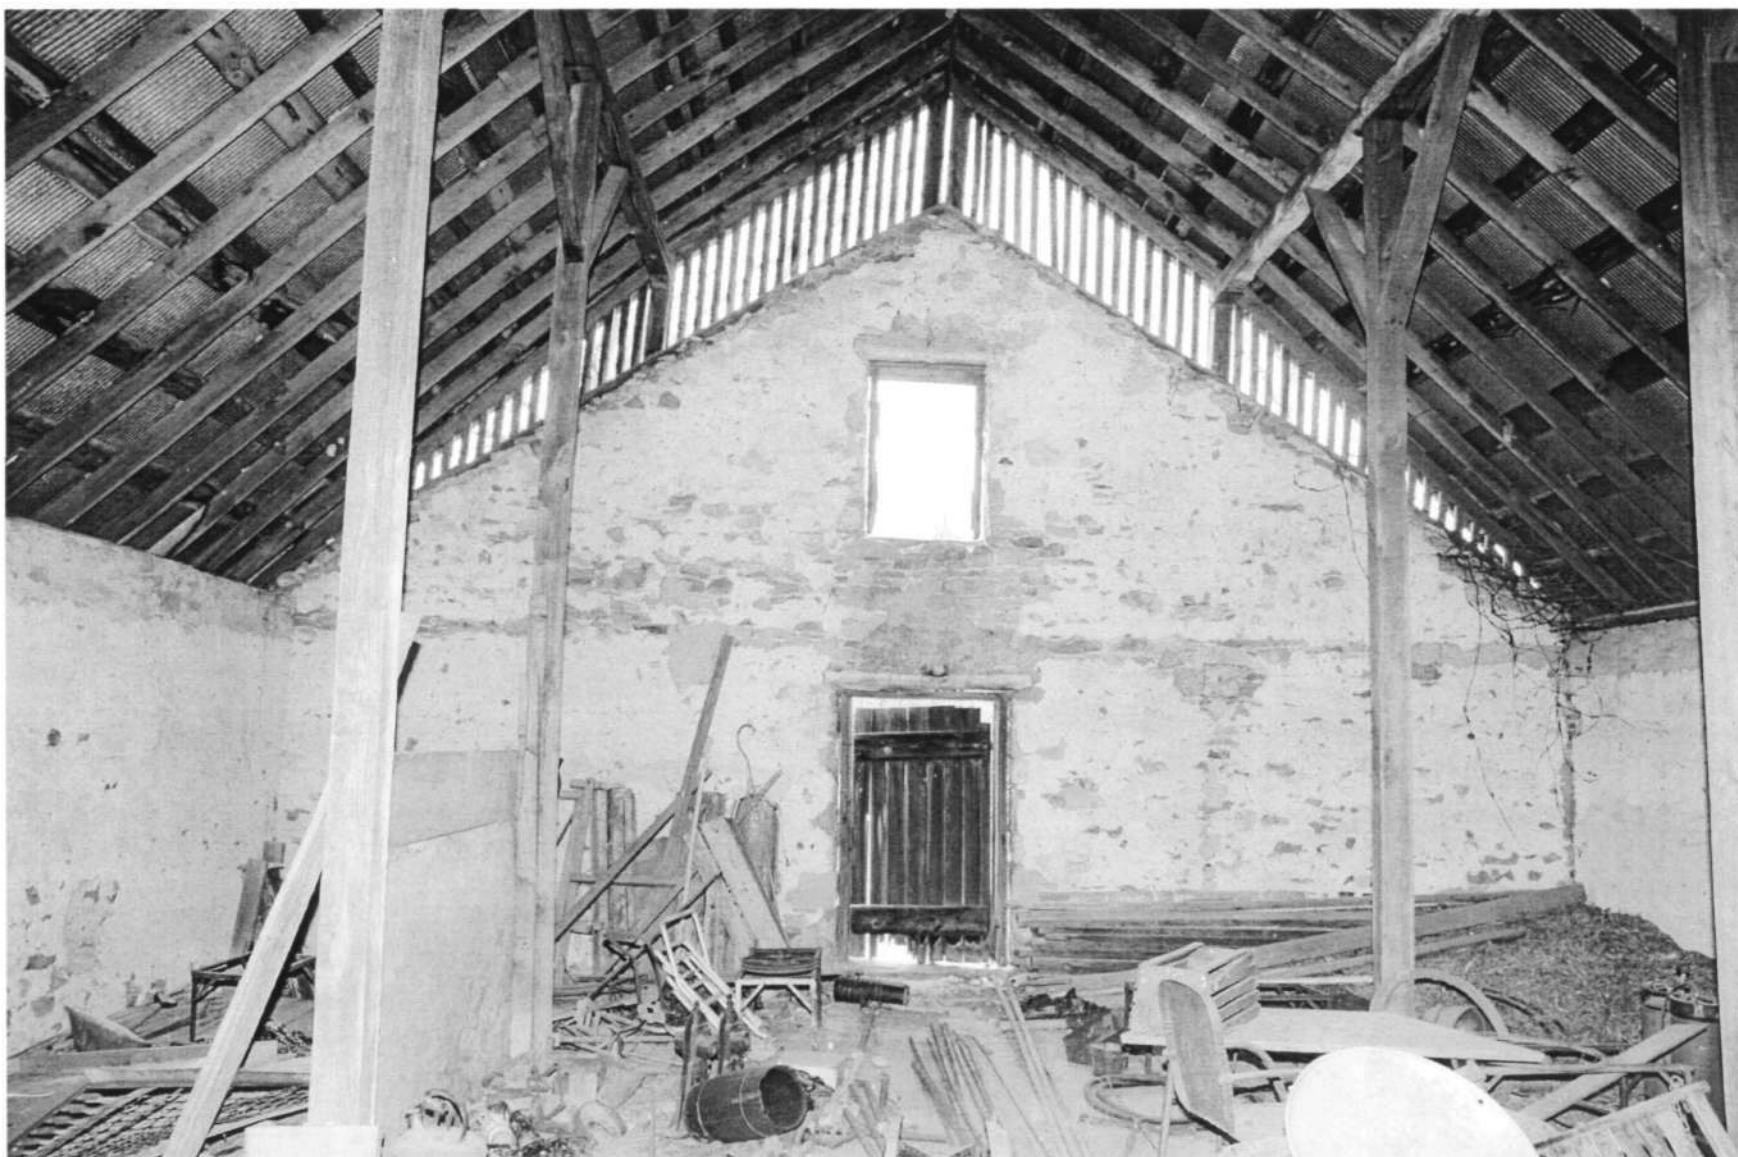
HO- 49 Mount Hebron, Calvin Circle & Furrow Avenue Stone Barn/Slave Quarter, second story, vw. southeast
Ken Short, April 2006, 22/30

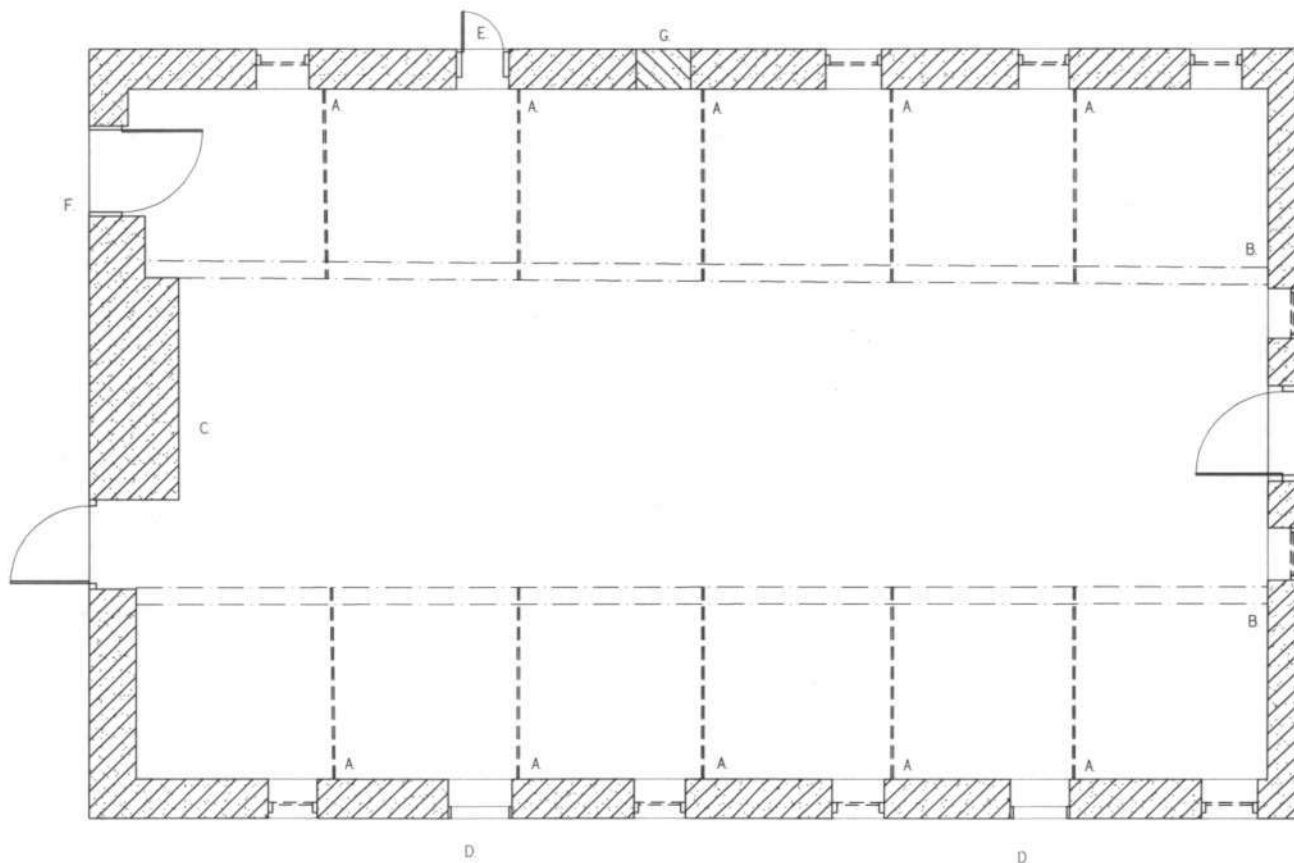
HO-49 "MT. HEBRON" STONE STABLE FURROW AVENUE

- A Board partitions based on ghosts in plaster on walls and nail evidence on joists.
- B Reflected summer beams - indicated by pockets in wall and ghosts on some joists. Replacement summer beams and posts not shown.
- C Fireplace closed off
- D Openings enlarged and converted to louvered vents.
- E Opening enlarged and converted to small door.
- F Doorway added.
- G Original opening closed off

FIRST FLOOR PLAN - MEASURED BY KEN SHORT, TOM REINHART, AND LAURA DORSEY - DRAWN BY KEN SHORT - SEPTEMBER 2007

stable should have had hatches, too, through which to drop hay to the stalls below, but the floor seems to be mostly intact, with no evidence of any hatches. By all appearances the floor is original, though it is possible that it was completely replaced in the nineteenth century, perhaps after the function of the building changed.

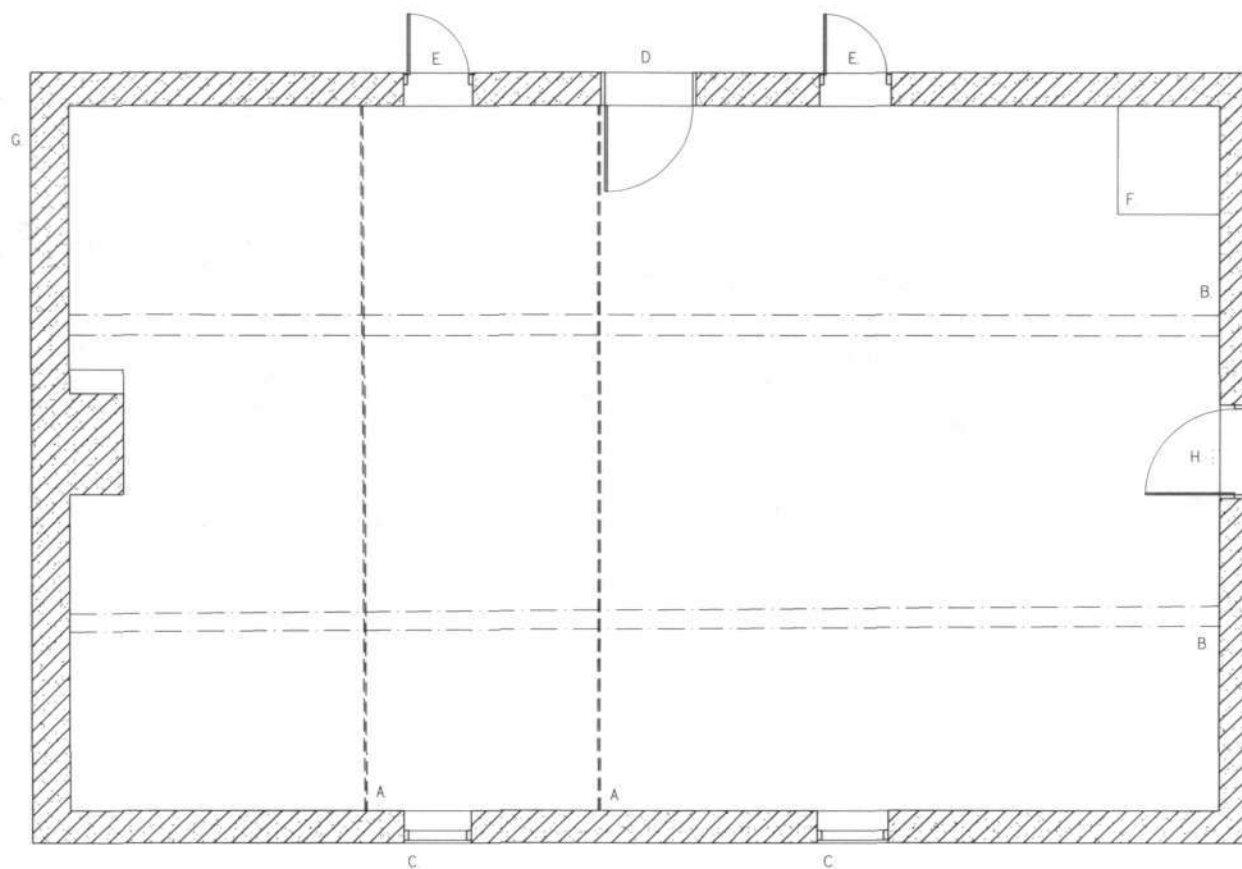
HO-49 "MT. HEBRON" STONE STABLE FURROW AVENUE

- A Board partitions based on ghosts in plaster on walls and pockets in wall for horizontal center nailing beam
- B Reflected, missing summer beams - indicated by pockets in wall
- C Openings converted to louvered vents
- D Doorway added
- E Openings converted to short doors
- F Opening cut through floor for ladder
- G Wall rebuilt here, dated "1941"
- H Reflected beam

SECOND FLOOR PLAN - MEASURED BY KEN SHORT, TOM REINHART, AND LAURA DORSEY - DRAWN BY KEN SHORT - SEPTEMBER 2007

According to Mr. Baker, the Baker family stored corn on the second floor of the stone barn or quarter and beans on the third floor. A heavy snow in 1941 caused the roof to cave in, and when it was rebuilt the third floor was taken out. They then kept heifers in the barn. There was a tenant house on the farm, south of the CMU building.

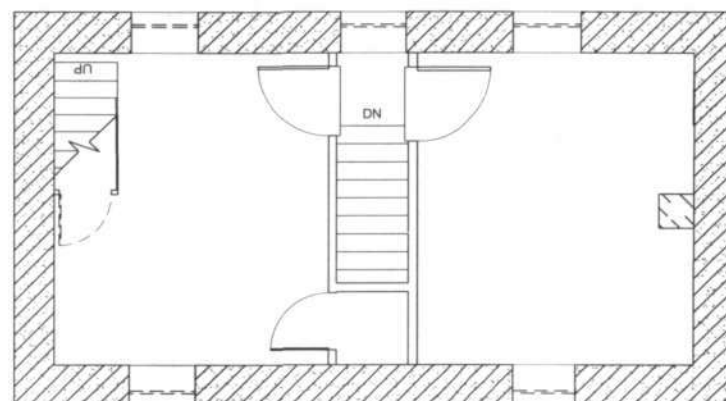
HO-49 MT. HEBRON OVERSEER'S HOUSE FURROW AVENUE

SECOND FLOOR PLAN - MEASURED BY KEN SHORT AND TOM REINHART - DRAWN BY KEN SHORT - JANUARY 2008

The interior of the supervisor's house is intact, but is in poor condition. The house has a double cell, single pile plan. The addition likely housed a kitchen. The stair between the 1st and 2nd floors is located in the western room and is located on the center partition. The stair between the 2nd floor and the attic is located on the western wall of the western room. The house retains wood floors, plaster walls, a wood mantel, wood four-panel doors, and simple beaded wood trim. There is no interior communication between the cellar and the 1st floor. The cellar of the main house is a workroom. A spring is located in the cellar of the addition.

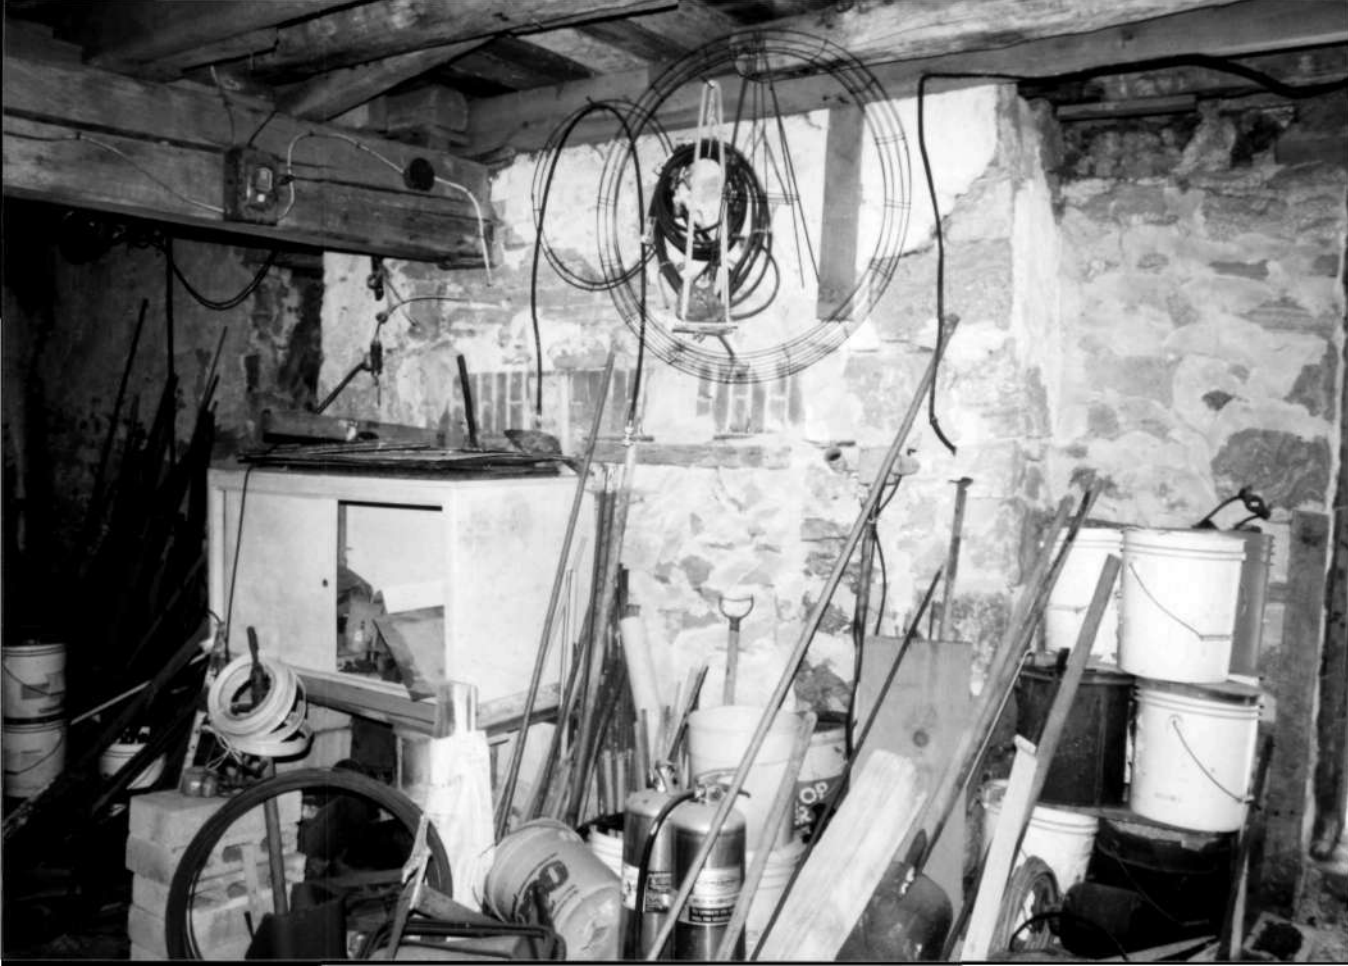
Shows fireplace 1st floor

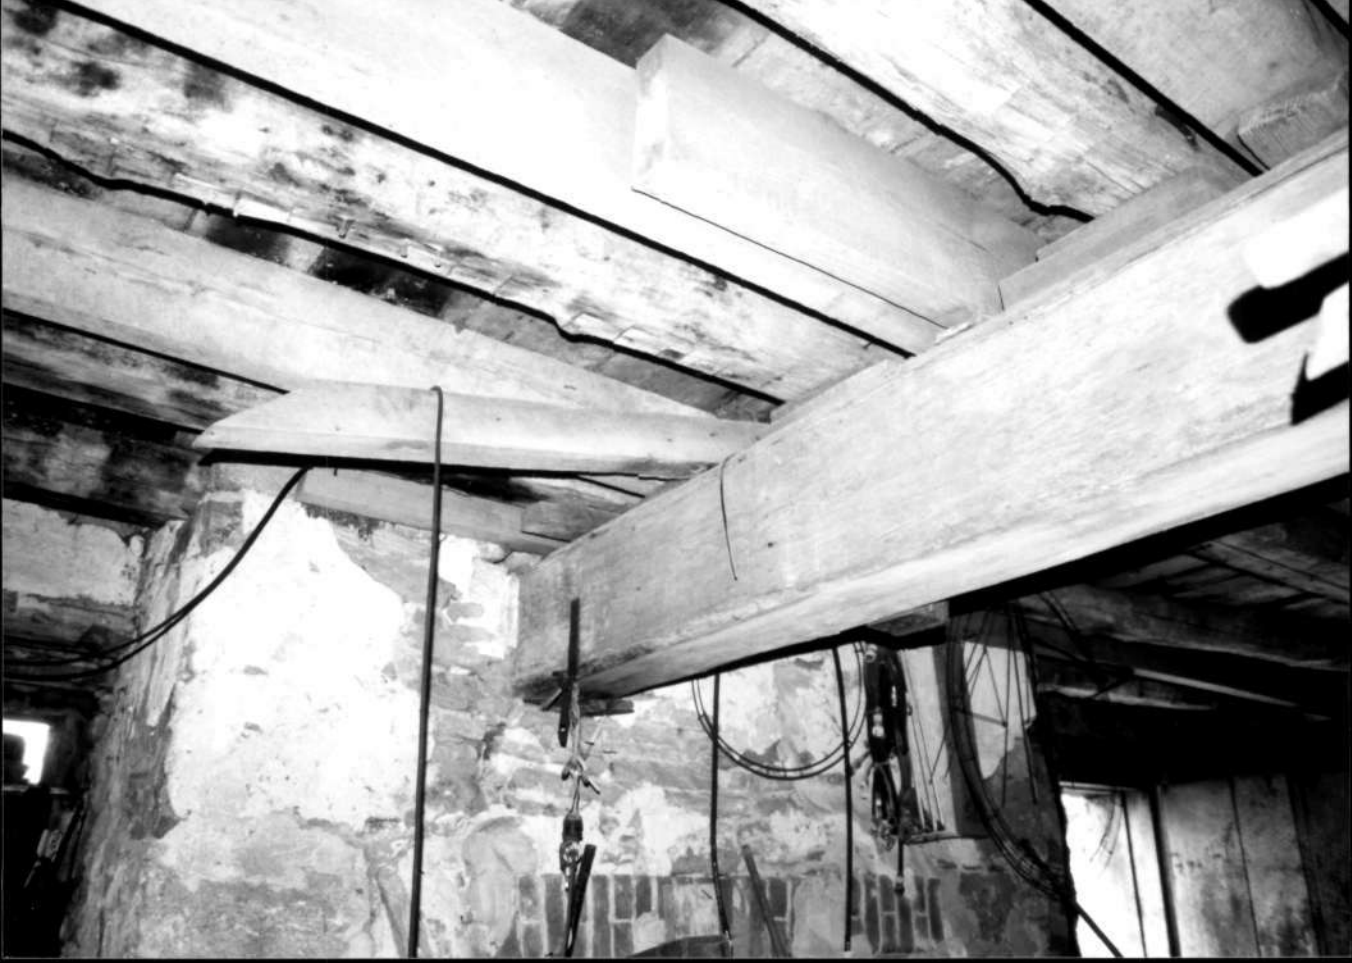
View NW. Shows 1st floor framing.

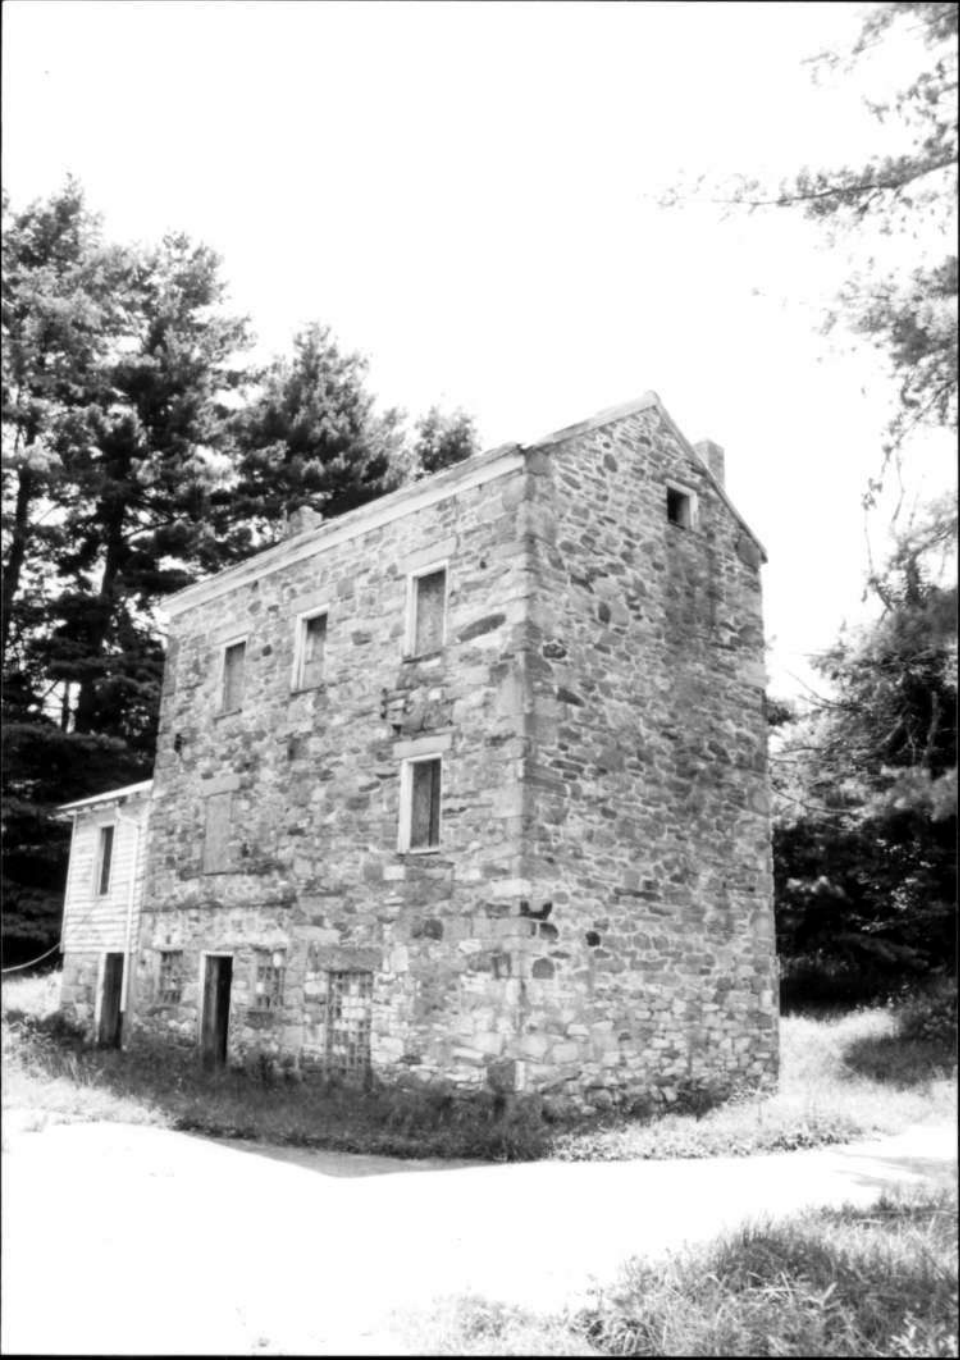
View SE. Shows supervisor's house.

A stone supervisor's house (ca. 1860s) in fair to good condition is located at the southern end of the building complex. The supervisor's house is a 2 ½ story plus cellar, 3-bay stone house with a side-gable roof. The house is constructed of stone, has wood six-over-six windows, and a corrugated metal roof. Openings have stone lintels and wood sills. A 1-story wood hipped roof addition on a stone foundation projects from the east façade. While structurally sound, the building has been empty for decades and is suffering from deferred maintenance.

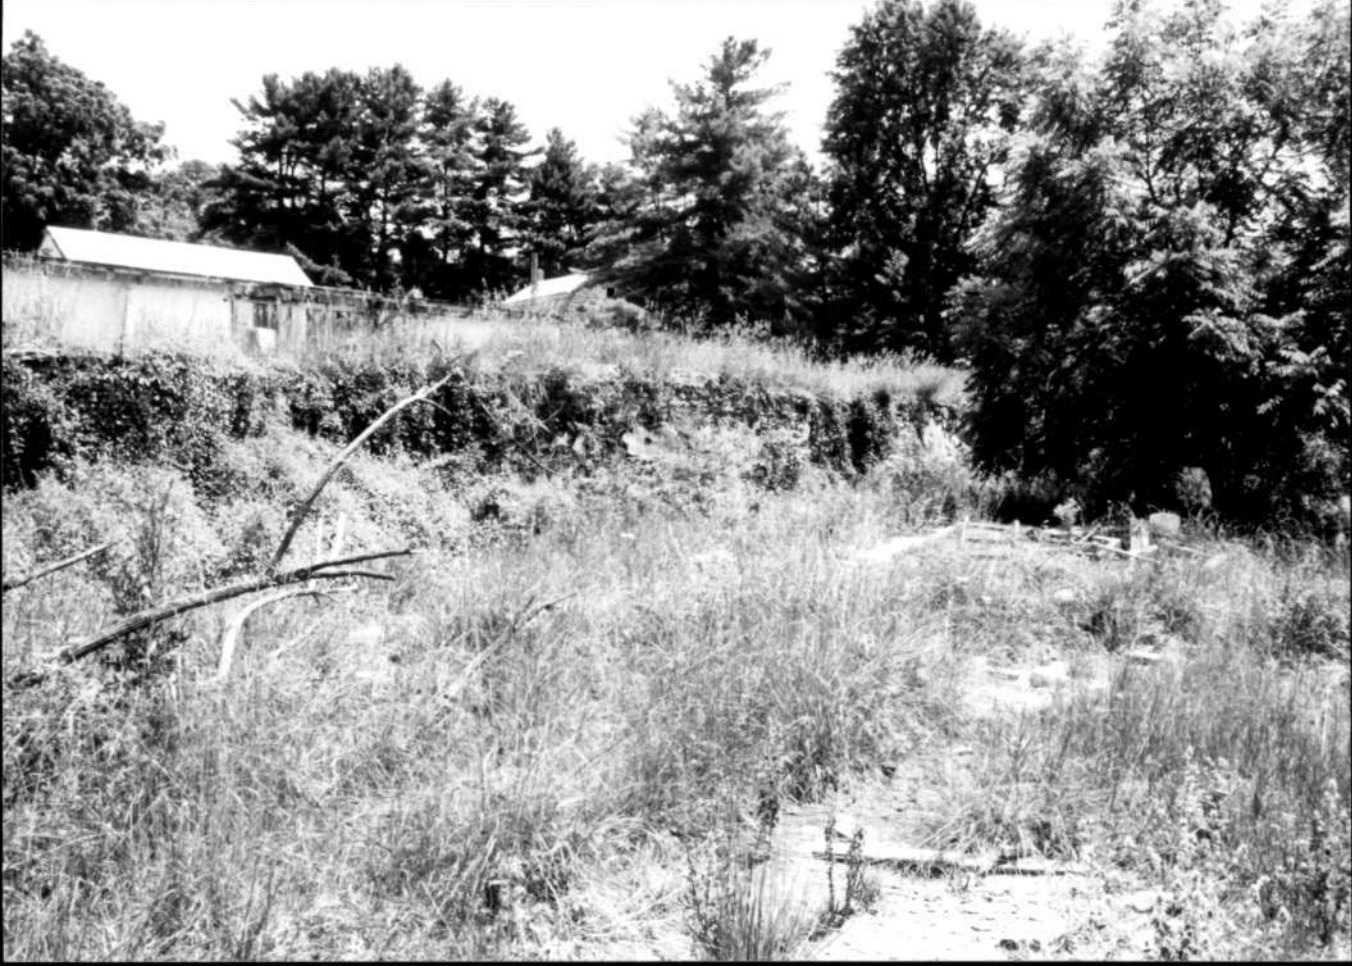
View S. Shows barn foundation.

Sections of the stone foundation of a second large barn remain west of the bank barn and dairy. This barn appears in the historic photo and was similar to the remaining bank barn, but provided stabling for horses in the ground floor story rather than cattle shelter.

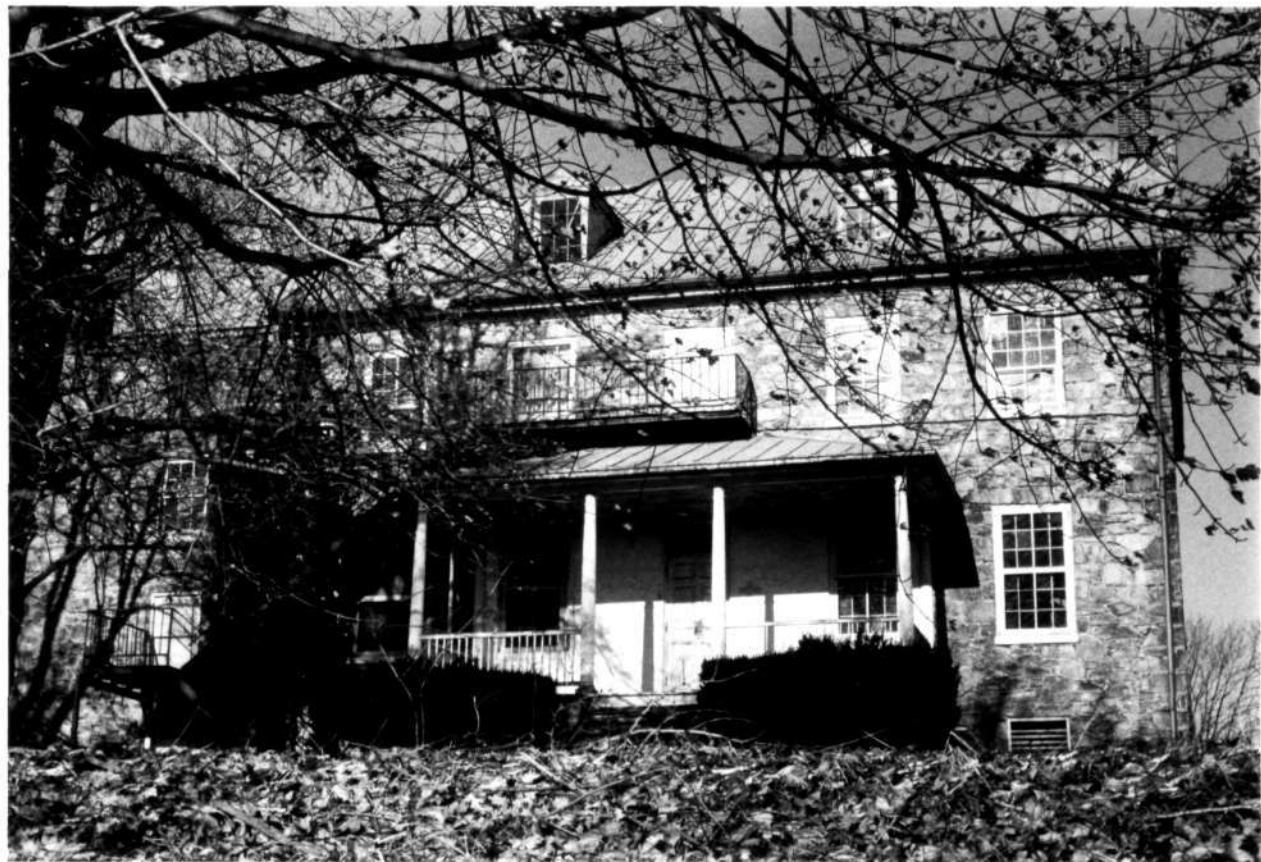
DIST. 2 HO-49
MT. HEBRON
FRONT ELEVATION
CB THOMPSON

This two-½ story, five bay wide stone structure is reminiscent of Font Hill and Woodlawn with its gabled roof, fine proportions and heavy granite block construction laid on a stone foundation. Two gabled roof dormers are inset into the gabled roof of the east elevation which hold double hung windows with six-over-six lights.
